Events and highlights on the progress related to recovery operations at TEPCO's Fukushima Daiichi Nuclear Power Station

June 2020

The Government of Japan

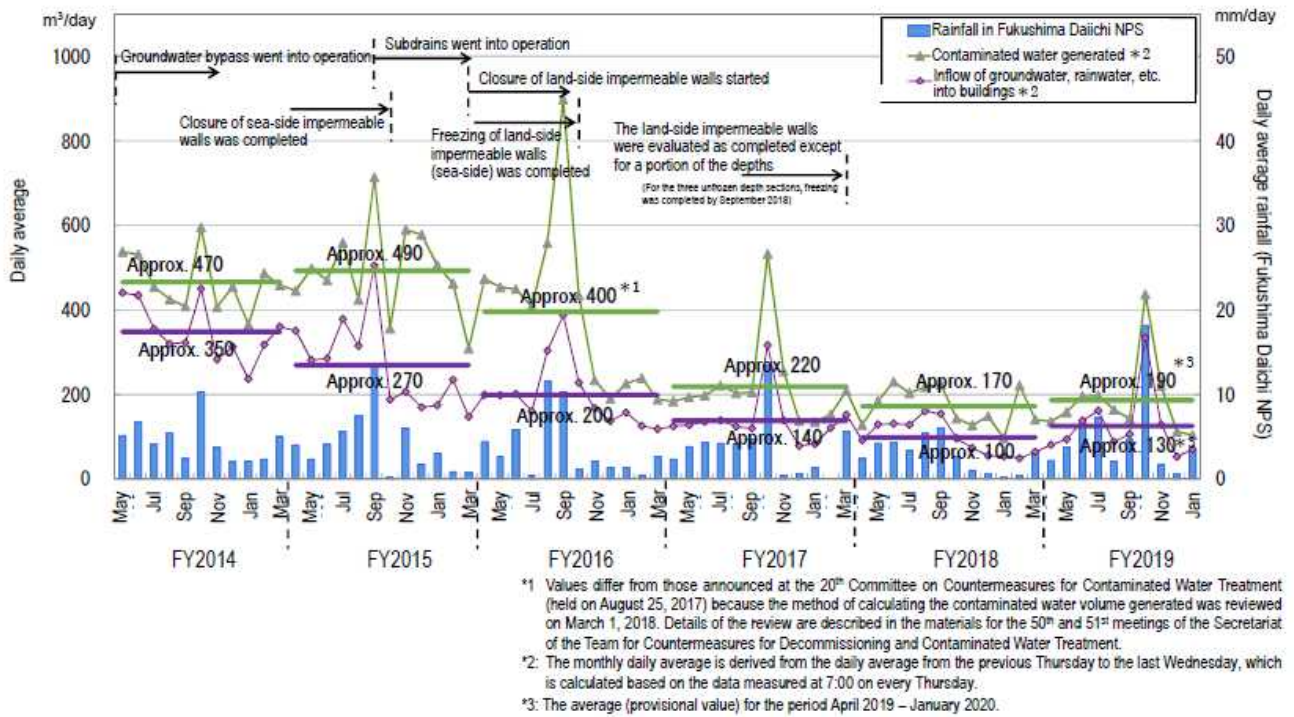
Following the steady implementation of measures (groundwater bypass, subdrains, land-side impermeable walls, etc.), the inflow of the groundwater and rainwater into buildings reduced from approx. 350 m³/day (in FY2014) to approx. 100 m³/day (in FY2018), though it depends on rainfall.

Subsequently, the generation of contaminated water decreased from approx. 470 m³/day (in FY2014) to approx. 170 m³/day (in FY2018).

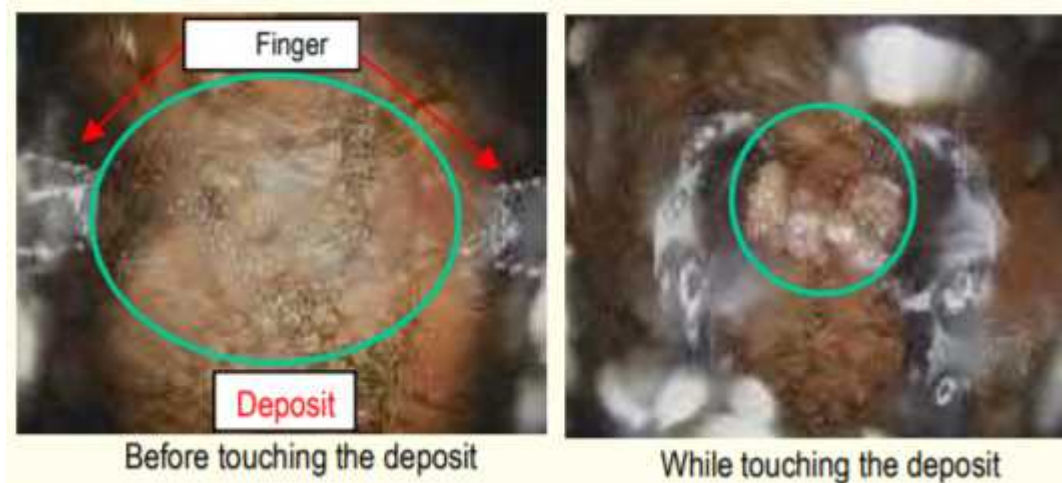
Image: Before and while touching the deposit at the investigation of Unit 2

On February 13, 2019, a contact investigation on the detected deposits inside the PCV was conducted to determine their characteristics (hardness, fragility, etc.). This contact investigation confirmed that the pebble-shaped deposits, etc. could be moved and that hard rock-like deposits that could not be gripped may exist. In addition, images of radiation dose and temperature data that would help determine the contour and size of the deposits could be collected by moving the investigative unit closer to the deposits. The result of this investigation will be utilized in the internal investigation in the second half of FY 2019, examination of the retrieval method.
